**Flood Control Project Maintenance
Levee Inspections****LMA District Cover Sheet****Spring 2012 Levee Inspection Results****Reclamation District No. 0785 Driver**

Levee Inspection Report By Mile - Spring 2012

Waterway						Bank	Unit Miles	Inspection Start/End	Inspector
Unit No. 01 Sacramento River						Right	2.31	04/03/2012 04/20/2012	John Williamson
LMR No.	Levee Mile		Category	Item	Location * + Rating	Action/Comment	GPS Latitude/Longitude		Issue No.
	Start	End					Start	End	Photo
1			Earthen Levee	Operations & Maintenance Manuals	LS Ma		°	°	10
DWR ID: DWR_RD0785_01_s_2012_10									
2			Earthen Levee	Emergency Supplies & Equipment	LS Ma	Inspector Comments: Supplies are stored at Elkhorn Firehouse	°	°	49
DWR ID: DWR_RD0785_01_s_2012_49									
3			Earthen Levee	Flood Preparedness & Training	LS Ma		°	°	50
DWR ID: DWR_RD0785_01_s_2012_50									
4	0.13	1.36	Earthen Levee	Trim / Thin Trees	LS Ma	T5 : Tree stumps.	38.660160 ° -121.611619 °	38.646214 ° -121.598596 °	4 Y
DWR ID: DWR_RD0785_01_s_2012_4									
5	0.29	0.29	Earthen Levee	Vegetation	LS A/W Ma	V4 : Elderberries are blocking visibility and flood fight capability.	38.658467 ° -121.609573 °	38.658467 ° -121.609573 °	1 Y

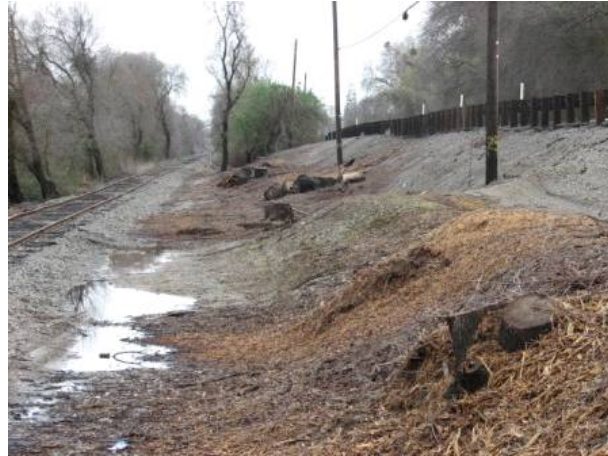
Levee Mile Report Line	4
Start Levee Mile	0.13
End Levee Mile	1.36
Location	Land Side
Category	Earthen Levee
Item	Trim / Thin Trees
The trees were cut by PG&E'S tree contractor. The district will take care of the stumps in the future.	
johngw_s_20120313_310.jpg

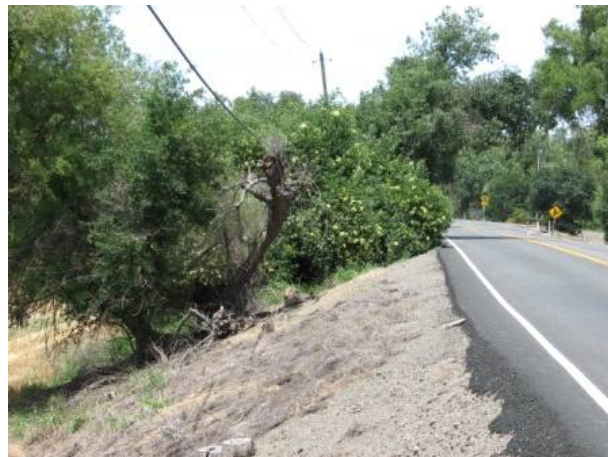
Levee Mile Report Line	5
Start Levee Mile	0.29
End Levee Mile	0.29
Location	Land Side
Category	Earthen Levee
Item	Vegetation
Elderberry	
johngw_s_20120313_306.jpg

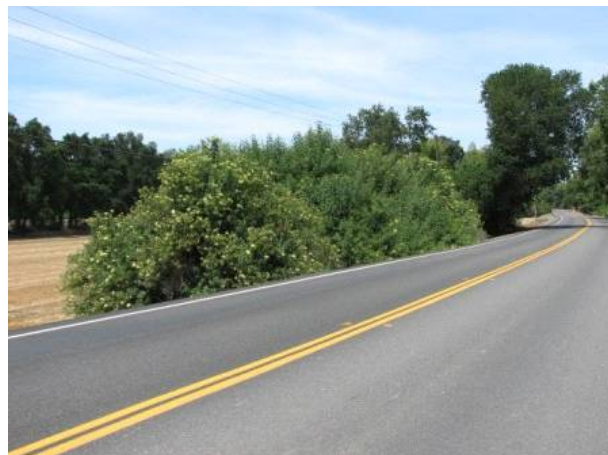
Levee Mile Report Line	6
Start Levee Mile	0.41
End Levee Mile	0.45
Location	Land Side
Category	Earthen Levee
Item	Vegetation
Elderberry	
johngw_s_20120313_307.jpg

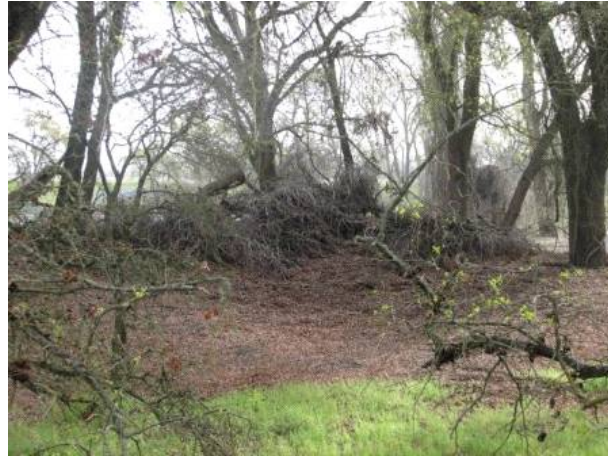
Levee Mile Report Line	7
Start Levee Mile	0.68
End Levee Mile	0.68
Location	Land Side
Category	Earthen Levee
Item	Encroachments
A pruning pile is on the landside of the levee slope, photo taken spring 2012	
johngw_s_20120409_624.jpg

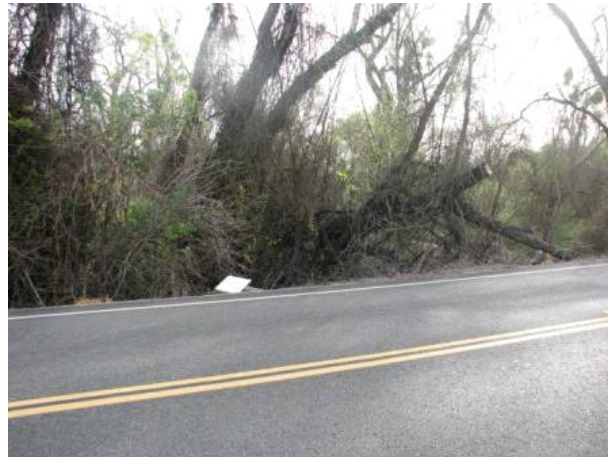
Levee Mile Report Line	10
Start Levee Mile	0.93
End Levee Mile	0.93
Location	Water Side
Category	Earthen Levee
Item	Trim / Thin Trees
The fallen tree and brush on the waterside of the roadway needs to be removed. Photo taken spring 2012	
johngw_s_20120409_625.jpg

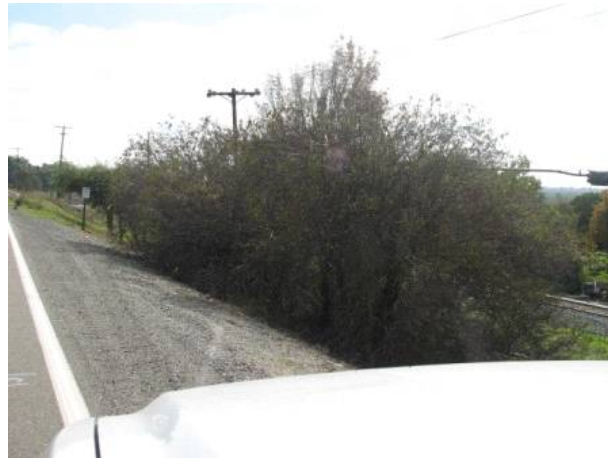
Levee Mile Report Line	12
Start Levee Mile	1.32
End Levee Mile	1.32
Location	Land Side
Category	Earthen Levee
Item	Vegetation

This is a very large Elderberry bush

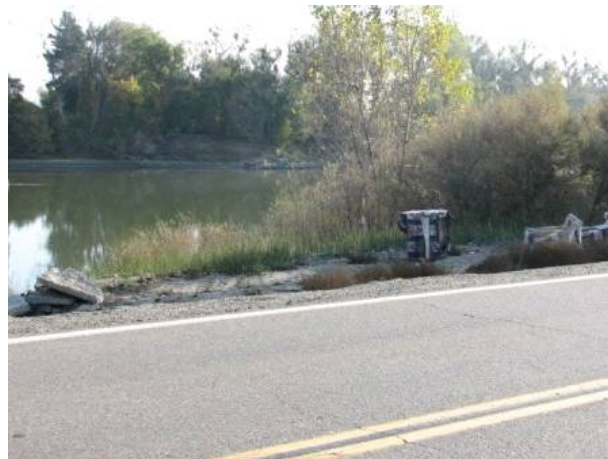
Levee Mile Report Line	13
Start Levee Mile	1.39
End Levee Mile	1.39
Location	Water Side
Category	Earthen Levee
Item	Encroachments

There is concrete debris and furniture that has been dropped off. Fall 2011

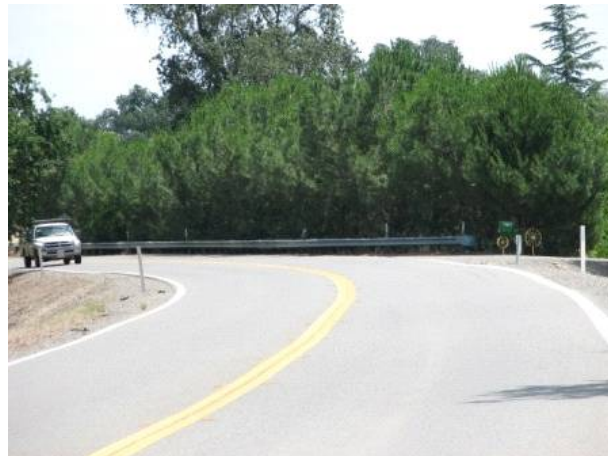
Levee Mile Report Line	14
Start Levee Mile	2.04
End Levee Mile	2.14
Location	Land Side
Category	Earthen Levee
Item	Vegetation

Pines and oleanders along shoulder.

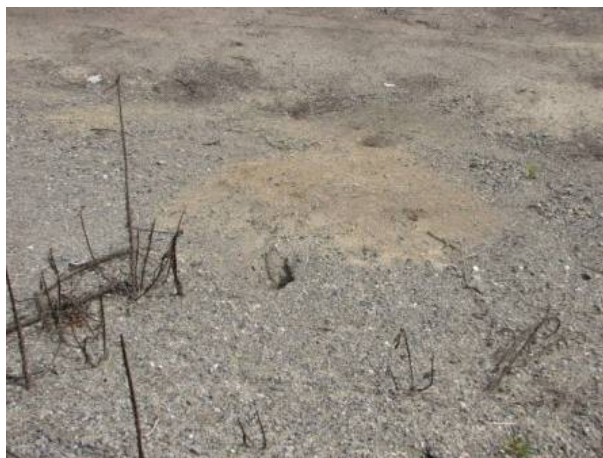
Levee Mile Report Line	1
Start Levee Mile	0.11
End Levee Mile	0.11
Location	Land Side
Category	Earthen Levee
Item	Animal Control

Rodent holes on the landside levee slope, photo taken spring 2012.

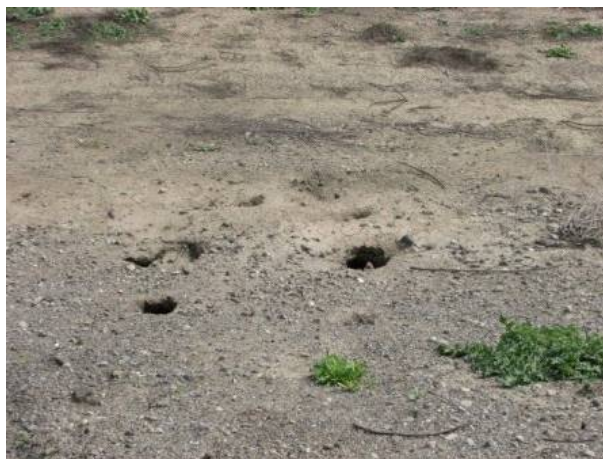
Levee Mile Report Line	3
Start Levee Mile	0.38
End Levee Mile	0.38
Location	Land Side
Category	Earthen Levee
Item	Animal Control

Rodent holes on the landside levee slope, photo taken spring 2012.

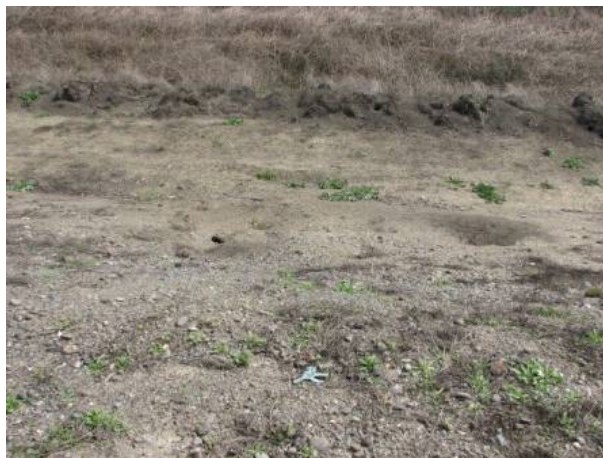
Levee Mile Report Line	4
Start Levee Mile	0.46
End Levee Mile	0.46
Location	Land Side
Category	Earthen Levee
Item	Animal Control

Rodent holes on the landside levee slope, photo taken spring 2012.

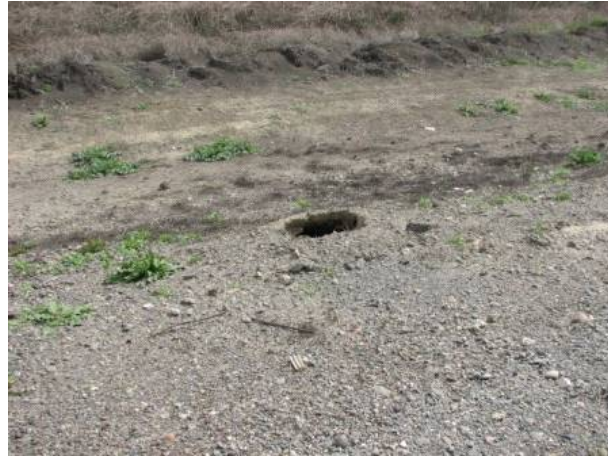
Levee Mile Report Line	4
Start Levee Mile	0.46
End Levee Mile	0.46
Location	Land Side
Category	Earthen Levee
Item	Animal Control

Many rodent holes with in 25' of each other, photo taken spring 2012.

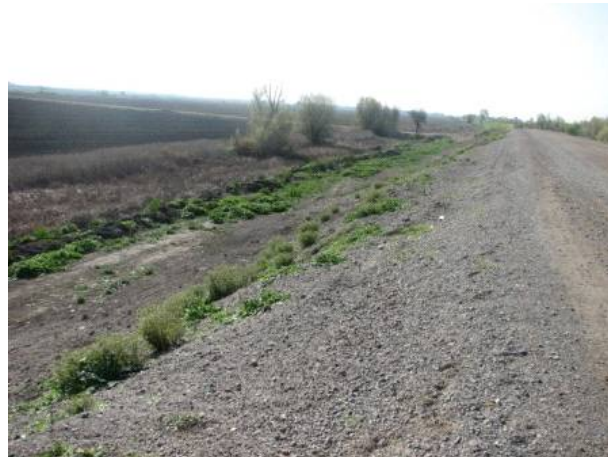
Levee Mile Report Line	5
Start Levee Mile	0.52
End Levee Mile	0.52
Location	Land Side
Category	Earthen Levee
Item	Slope Stability

Buldge at the landside toe of the levee, photos taken spring 2012.

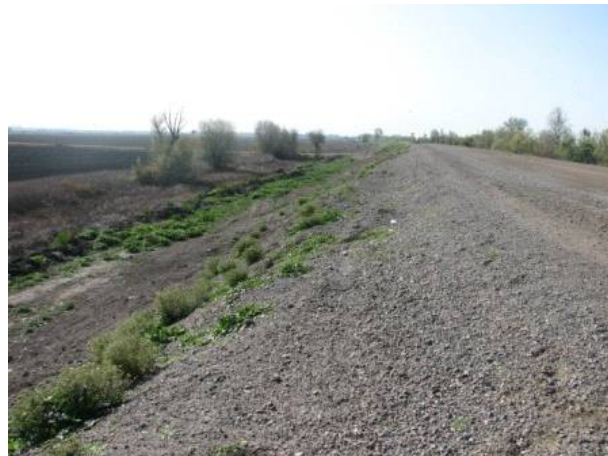
Levee Mile Report Line	5
Start Levee Mile	0.52
End Levee Mile	0.52
Location	Land Side
Category	Earthen Levee
Item	Slope Stability

Slope instability at shoulder of landside levee buldge at toe.

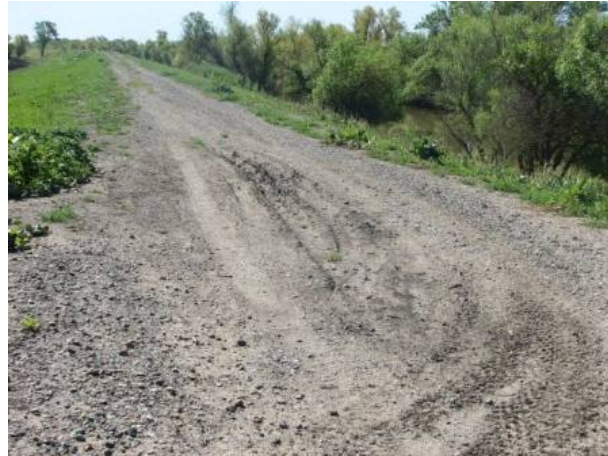
Levee Mile Report Line	6
Start Levee Mile	0.83
End Levee Mile	0.83
Location	Crown
Category	Earthen Levee
Item	Crown Surface / Depressions / Rutting
Tire ruts 6" deep need to grade and add base for all weather surface. Photo taken spring 2012.	
johngw_s_20120423_724.jpg

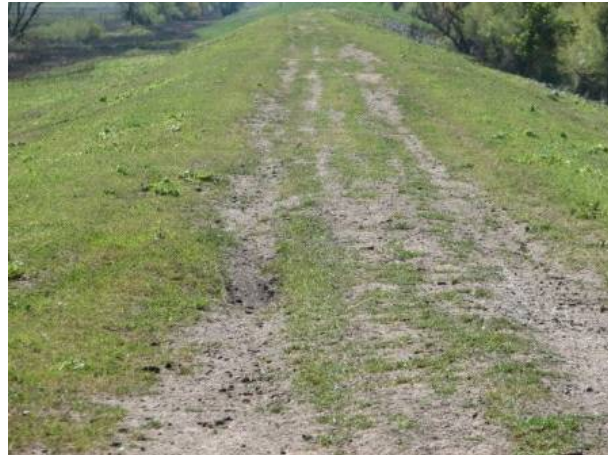
Levee Mile Report Line	7
Start Levee Mile	0.98
End Levee Mile	0.98
Location	Crown
Category	Earthen Levee
Item	Crown Surface / Depressions / Rutting
Crown roadway needs vegetation control and base material. Photo taken spring 2012	
johngw_s_20120423_725.jpg

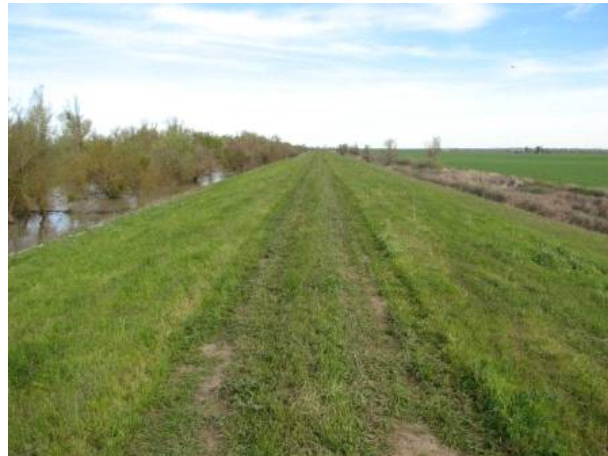
Levee Mile Report Line	8
Start Levee Mile	1.01
End Levee Mile	3.25
Location	Crown
Category	Earthen Levee
Item	Crown Surface / Depressions / Rutting
The vegetation on the crown needs to be sprayed and graded.	
johngw_s_20120313_314.jpg

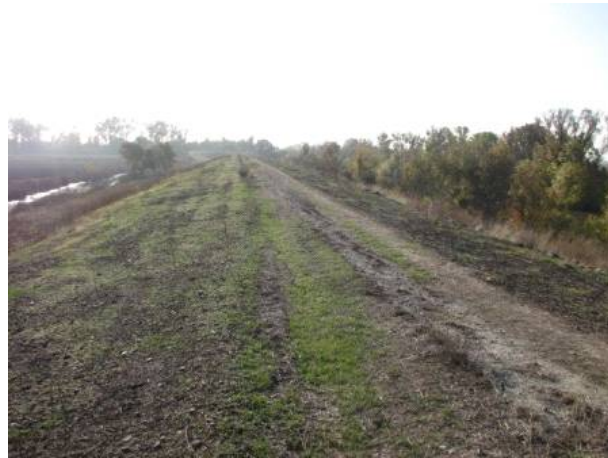
Levee Mile Report Line	8
Start Levee Mile	1.01
End Levee Mile	3.25
Location	Crown
Category	Earthen Levee
Item	Crown Surface / Depressions / Rutting
The vegetation on the crown has improved but needs to be sprayed. Fall 2011	
johngw_s_20120313_315.jpg

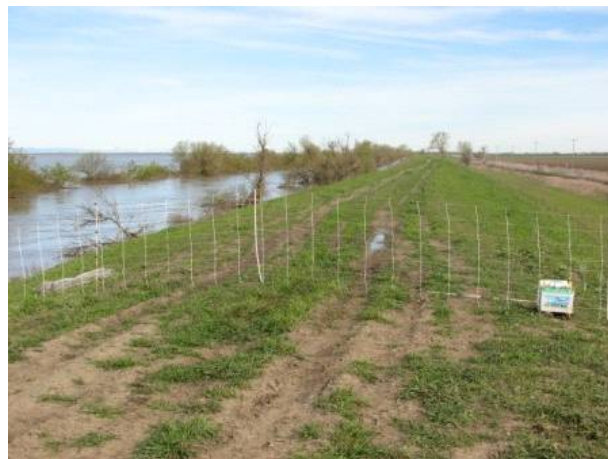
Levee Mile Report Line	9
Start Levee Mile	1.50
End Levee Mile	1.50
Location	Crown
Category	Earthen Levee
Item	Crown Surface / Depressions / Rutting
The crown of the levee with vegetation on the roadway. There is some depressions on the crown from vehicle use.	
johngw_s_20120313_316.jpg

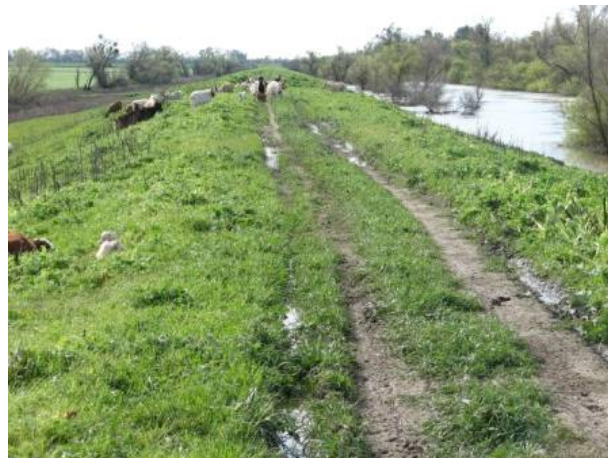
Levee Mile Report Line	10
Start Levee Mile	1.67
End Levee Mile	1.67
Location	Crown
Category	Earthen Levee
Item	Crown Surface / Depressions / Rutting
The crown needs to have gravel added to have an all weather surface.	
johngw_s_20120313_317.jpg

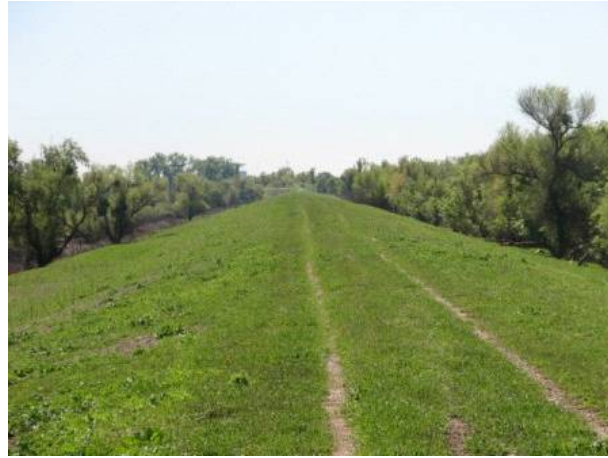
Levee Mile Report Line	11
Start Levee Mile	1.84
End Levee Mile	3.30
Location	Crown
Category	Earthen Levee
Item	Crown Surface / Depressions / Rutting
Crown roadway needs vegetation control. Photo taken spring 2012.	
johngw_s_20120423_726.jpg

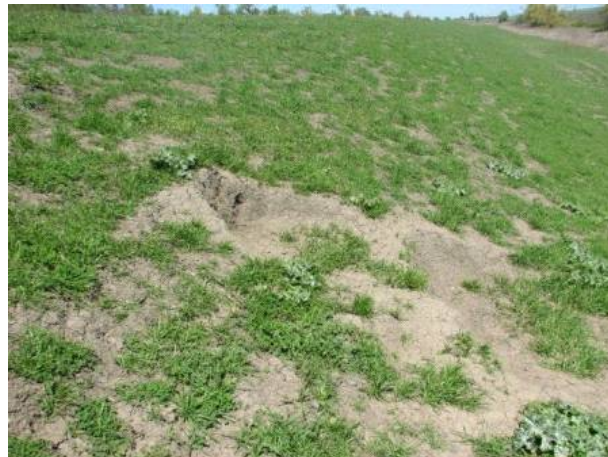
Levee Mile Report Line	12
Start Levee Mile	2.20
End Levee Mile	2.20
Location	Land Side
Category	Earthen Levee
Item	Slope Stability
There is slope instability with three step like spots. The cuts are 1' to 1.5' deep. Photo taken spring 2012.	
johngw_s_20120423_727.jpg
